St. Patrick Church Solves Slippery Step Problem with Form-A-Tread®

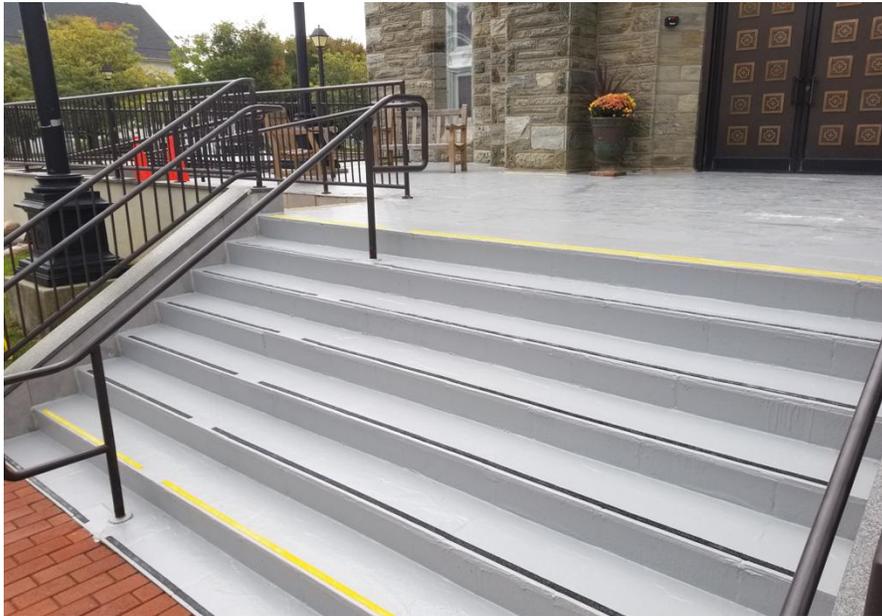
Problem: The new tile steps were slippery. To improve traction an epoxy coating with sand broadcasted on top was applied in 2012. The sand wore off in a few years so another epoxy coating was applied. Unfortunately the new coating was very slippery. The steps were so slippery that one parishioner fell and the Church had to close the front steps to pedestrian traffic. This was a major inconvenience and liability concern for this active Church.

Form-A-Tread[®], a 100% epoxy based material containing slip resistant properties and UV inhibitors was selected. Adhesion testing to the existing epoxy coating was conducted prior to installation. A 1" wide Black stripe was installed directly onto and ½" from the front edge of the step. To improve visibility especially in low light situations, Form-A-Tread Safety Yellow was applied on the bottom step and two 1" stripes on the top step. An additional 1" wide Black stripe was applied on the landing. The stairs are exposed to heavy foot traffic and weather extremes so Tread Grit[®] HD was sprinkled on after spreading for additional traction and durability.

Installation Time: Under 3 hours. Surface preparation consisted of removing dirt and loose coating with a stiff wire brush. Form-A-Tread was installed in the early afternoon and allowed to cure overnight. Steps were ready to receive foot traffic by 6AM the next morning. Temperature of install area = 60 to 75°F.

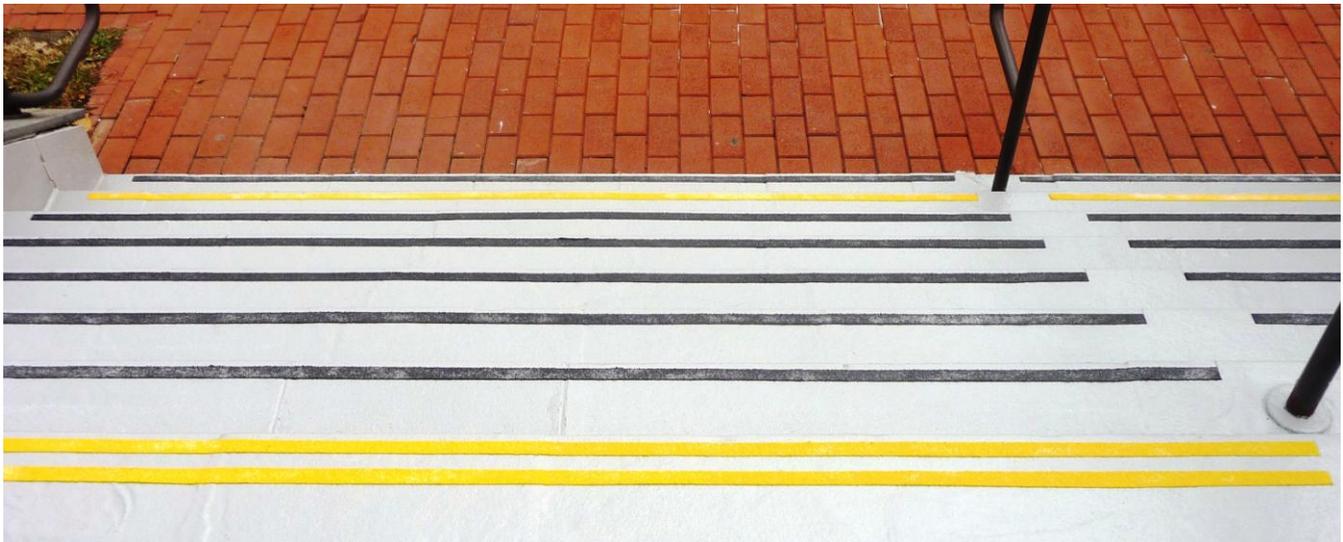
Summary: Traction, safety and visibility on St. Patrick Church front steps were greatly improved. The steps are open again and feedback from Church leadership, parishioners and students has been extremely positive.
