Tobyhanna Army Depot Improves Safety and Visibility with Form-A-Tread® Safety Yellow

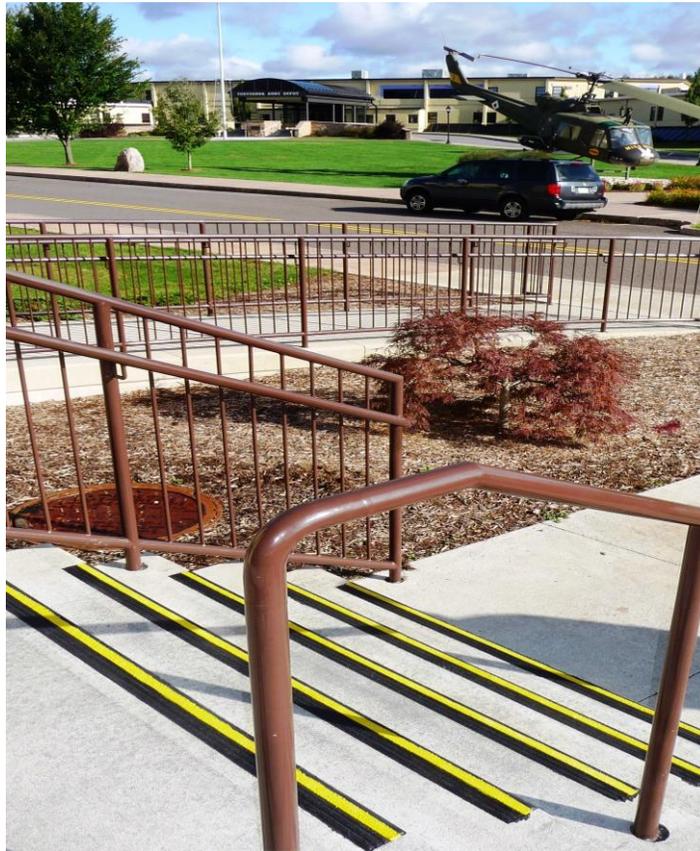
Problem: The new aluminum treads provided adequate traction but TYAD Safety Personnel received complaints, especially from employees with vision issues, that the new stairs were not safe due to poor visibility. It was discovered that the aluminum treads blended into the concrete making it difficult to see the edge of each step, especially during the short winter days.

The initial solution was to apply a coating of paint to the aluminum treads. This was a low cost approach but was rejected after it was determined the paint provided no traction, poor adhesion to aluminum and had started to peel and look unsightly in less than a week.

Form-A-Tread® Safety Yellow, a 100% epoxy based material containing slip resistant properties and UV inhibitor was selected. A 1" wide stripe was installed directly onto the existing aluminum tread, ½ from the front edge of the step. Stairs are exposed to heavy foot traffic and weather extremes so Tread Grit® HD (Heavy Duty) was applied for additional traction and durability.

Installation Time: Under 2 hours. Surface preparation consisted of removing dirt and loose paint with a wire brush. Form-A-Tread Safety Yellow was installed in the late afternoon and allowed to cure overnight. Steps were ready to receive foot traffic by 6AM the next morning. Temperature of install area = 70 to 85°F.
